Inspection Report

Mine Name: Lime Ridge

Permit number: M/037/081

Inspection Date: October 6, 2004

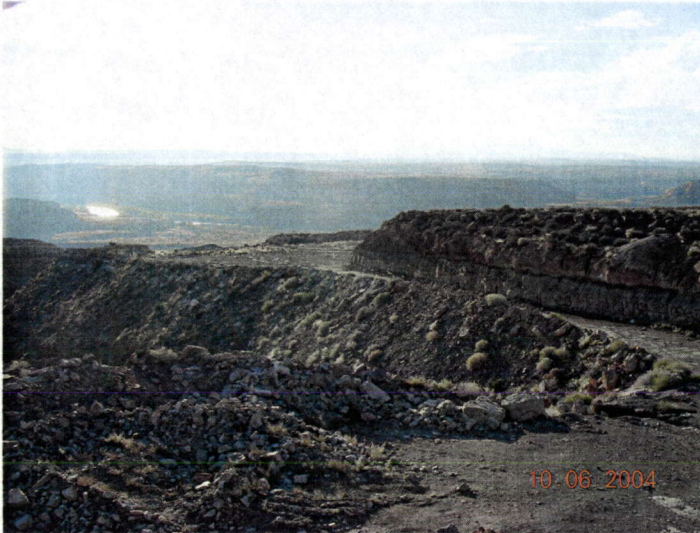
There is an area in the southeast part of the mine that the operator might no longer need and which could be reclaimed. The area shown in Photo 1 is on the south side of the drainage that dissects the mine. The surface facilities map in the plan calls this an old mining area. It should be reclaimed if it is not going to be used any more.

Photo 1. An old mining area on the southeast part of the site.

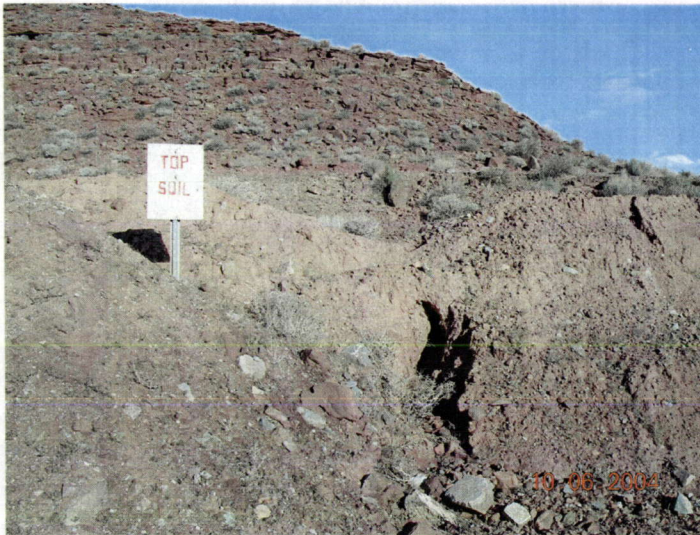
As one enters the site on the county road, there is some soil stockpiled on the northwest side of the road (Photo 2). On the map, this area is labeled "General," but there is a sign indicating it is topsoil. Some of this material has eroded on to the road. Although native vegetation is volunteering on this pile, I suggest that the operator seed it and the other soil stockpiles with grasses to reduce the amount of soil being lost.

Photo 2. The topsoil stockpile along the entrance road. Note the amount of erosion.

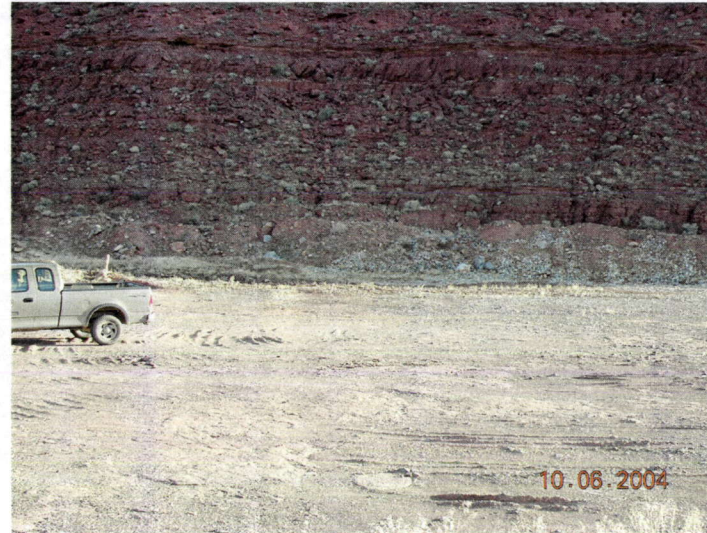
In the northwest part of the site is a pile labeled on the map as "Reject pile (Fill)," and this pile could also probably be used as soil (Photo 3).

Photo 3. A reject pile on the northwest side of the site. I believe most of this material should be useable as substitute soil.

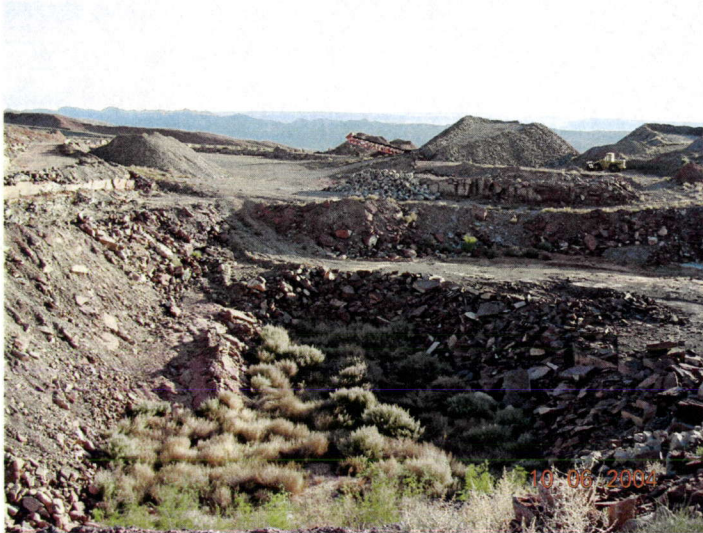
Photos 4-6 are general views of the area. Photo 4 shows some of the stockpiles on the east side of the site. The right side of Photo 5 is the drainage that goes through the site and continues toward the San Juan River. Photo 6 is an area just above the area shown in Photo 5. The depression in this photo would capture water from nearly all of the west portion of the mine.

Photo 4. In the background are some product stockpiles. The depression in the foreground is the same one shown in Photo 6.

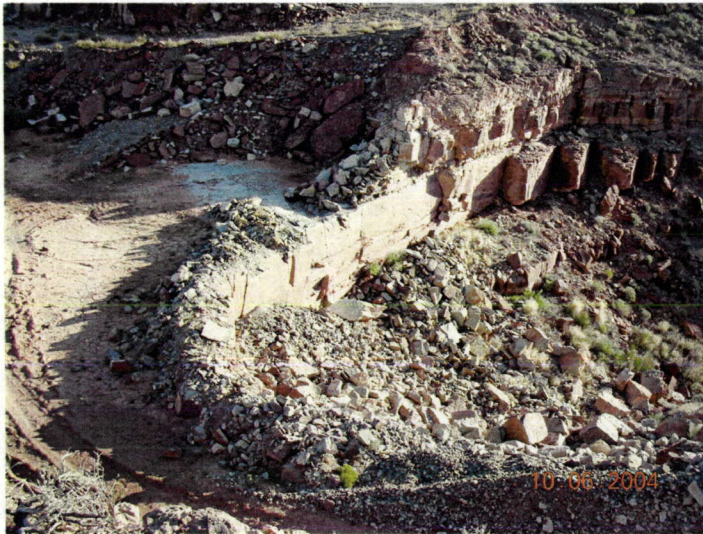
Photo 5. A drainage leading east toward the San Juan River.

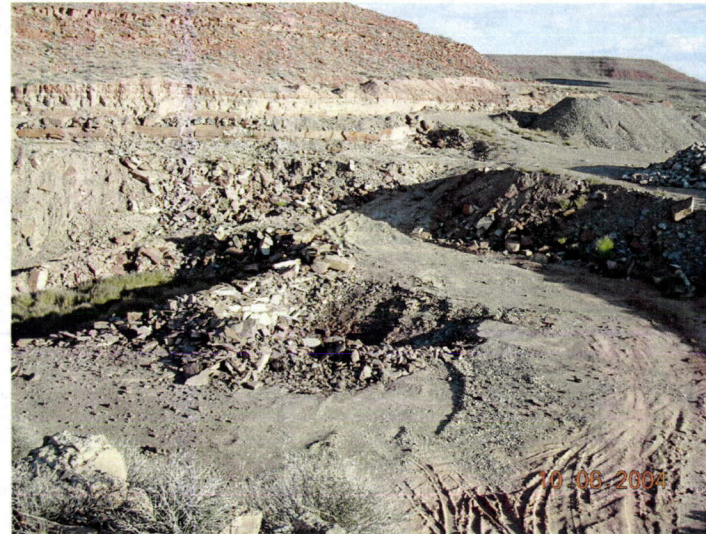
Photo 6. An access road going across the drainage shown in Photo 5. The depression on the left would capture most runoff from the western part of the site.
